# Niagara County

## Facelift to Benefit the Residents of Niagara County

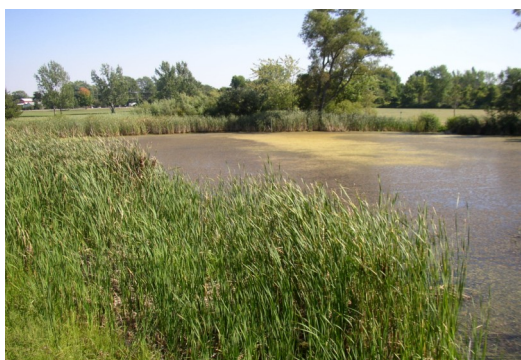
The Victor Fitchlee - Royalton Ravine Conservation Park is a 146-acre county-owned park, which is a popular location for conservation education events, hiking, camping and family picnics. Within the park is a 1.5 acre fishing pond that was constructed in the 1970's and was in need of some maintenance. The pond is a combination of an excavated and embankment pond where soil on a sloped field, just upstream of a ravine was excavated down to bedrock and was used to construct an embankment across the ravine at the low end of the field. The embankment backed water up in the excavated area behind the berm, creating the pond. Nearly forty years later, the dynamics of nature had taken its toll. Trees had begun growing on the embankment of the pond, which caused a concern for the long term stability of the earthen structure. Cattails had completely surrounded the pond and were over 20-feet wide in some places. Eurasian Milfoil, an invasive species, had also moved in, completely eliminating all but a couple hundred feet of open water in the pond. The pond's average depth was just over three feet deep, and was being reduced each year from the muck that was accumulating from decomposing vegetation and sediment. The excessive vegetation also afforded too much

**Royalton Ravine Pond before restoration.**

protection to smaller forage fish, which reportedly had substantially altered the bass population over the years. In the summer of 2008, the Niagara County Soil and Water Conservation District provided some long overdue maintenance to the pond; including removal of the excess vegetation in and around the pond and dredging of the accumulated muck in the bottom to restore the pond to its original depth.

Restoration began with the removal of trees and brush from the embankment berm. The berm was then re-graded and planted with grasses to prevent erosion. The majority of the mature trees on the upstream side of the pond were saved to maintain the mature characteristic of the pond and to provide shade to both fish and people. The trees that had to be removed to accommodate the dredging process were set aside and eventually placed in the pond to provide underwater structure for fish habitat and basking logs for the large turtle population. During the pond dredging, the shoreline access was improved by removing the ring of cattails around the pond, although certain areas will be allowed to revert back to provide habitat around the pond. Over 4,000 cubic yards of Eurasian Milfoil and muck was dredged from the pond. This provided an additional 3 acre-feet of water in the pond.

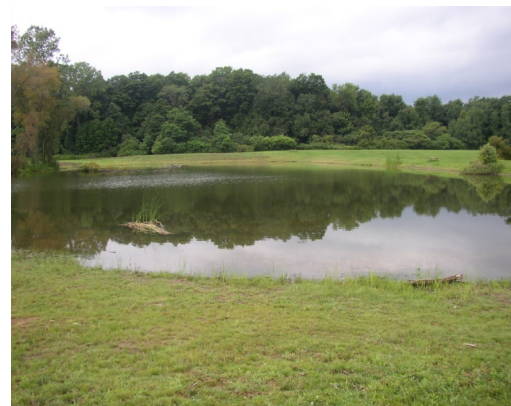
**Royalton Ravine Pond after restoration.**

The pond dredging project was completed in September 2008 and has been getting rave reviews from residents who haven't been able to use the pond for years.
